COMPLETION REPORT
FORMER BREMERTON MGP SITE
INCIDENT ACTION AND TIME CRITICAL REMOVAL ACTION

Cascade Natural Gas Corporation

Anchor QEA, LLC

January 2011

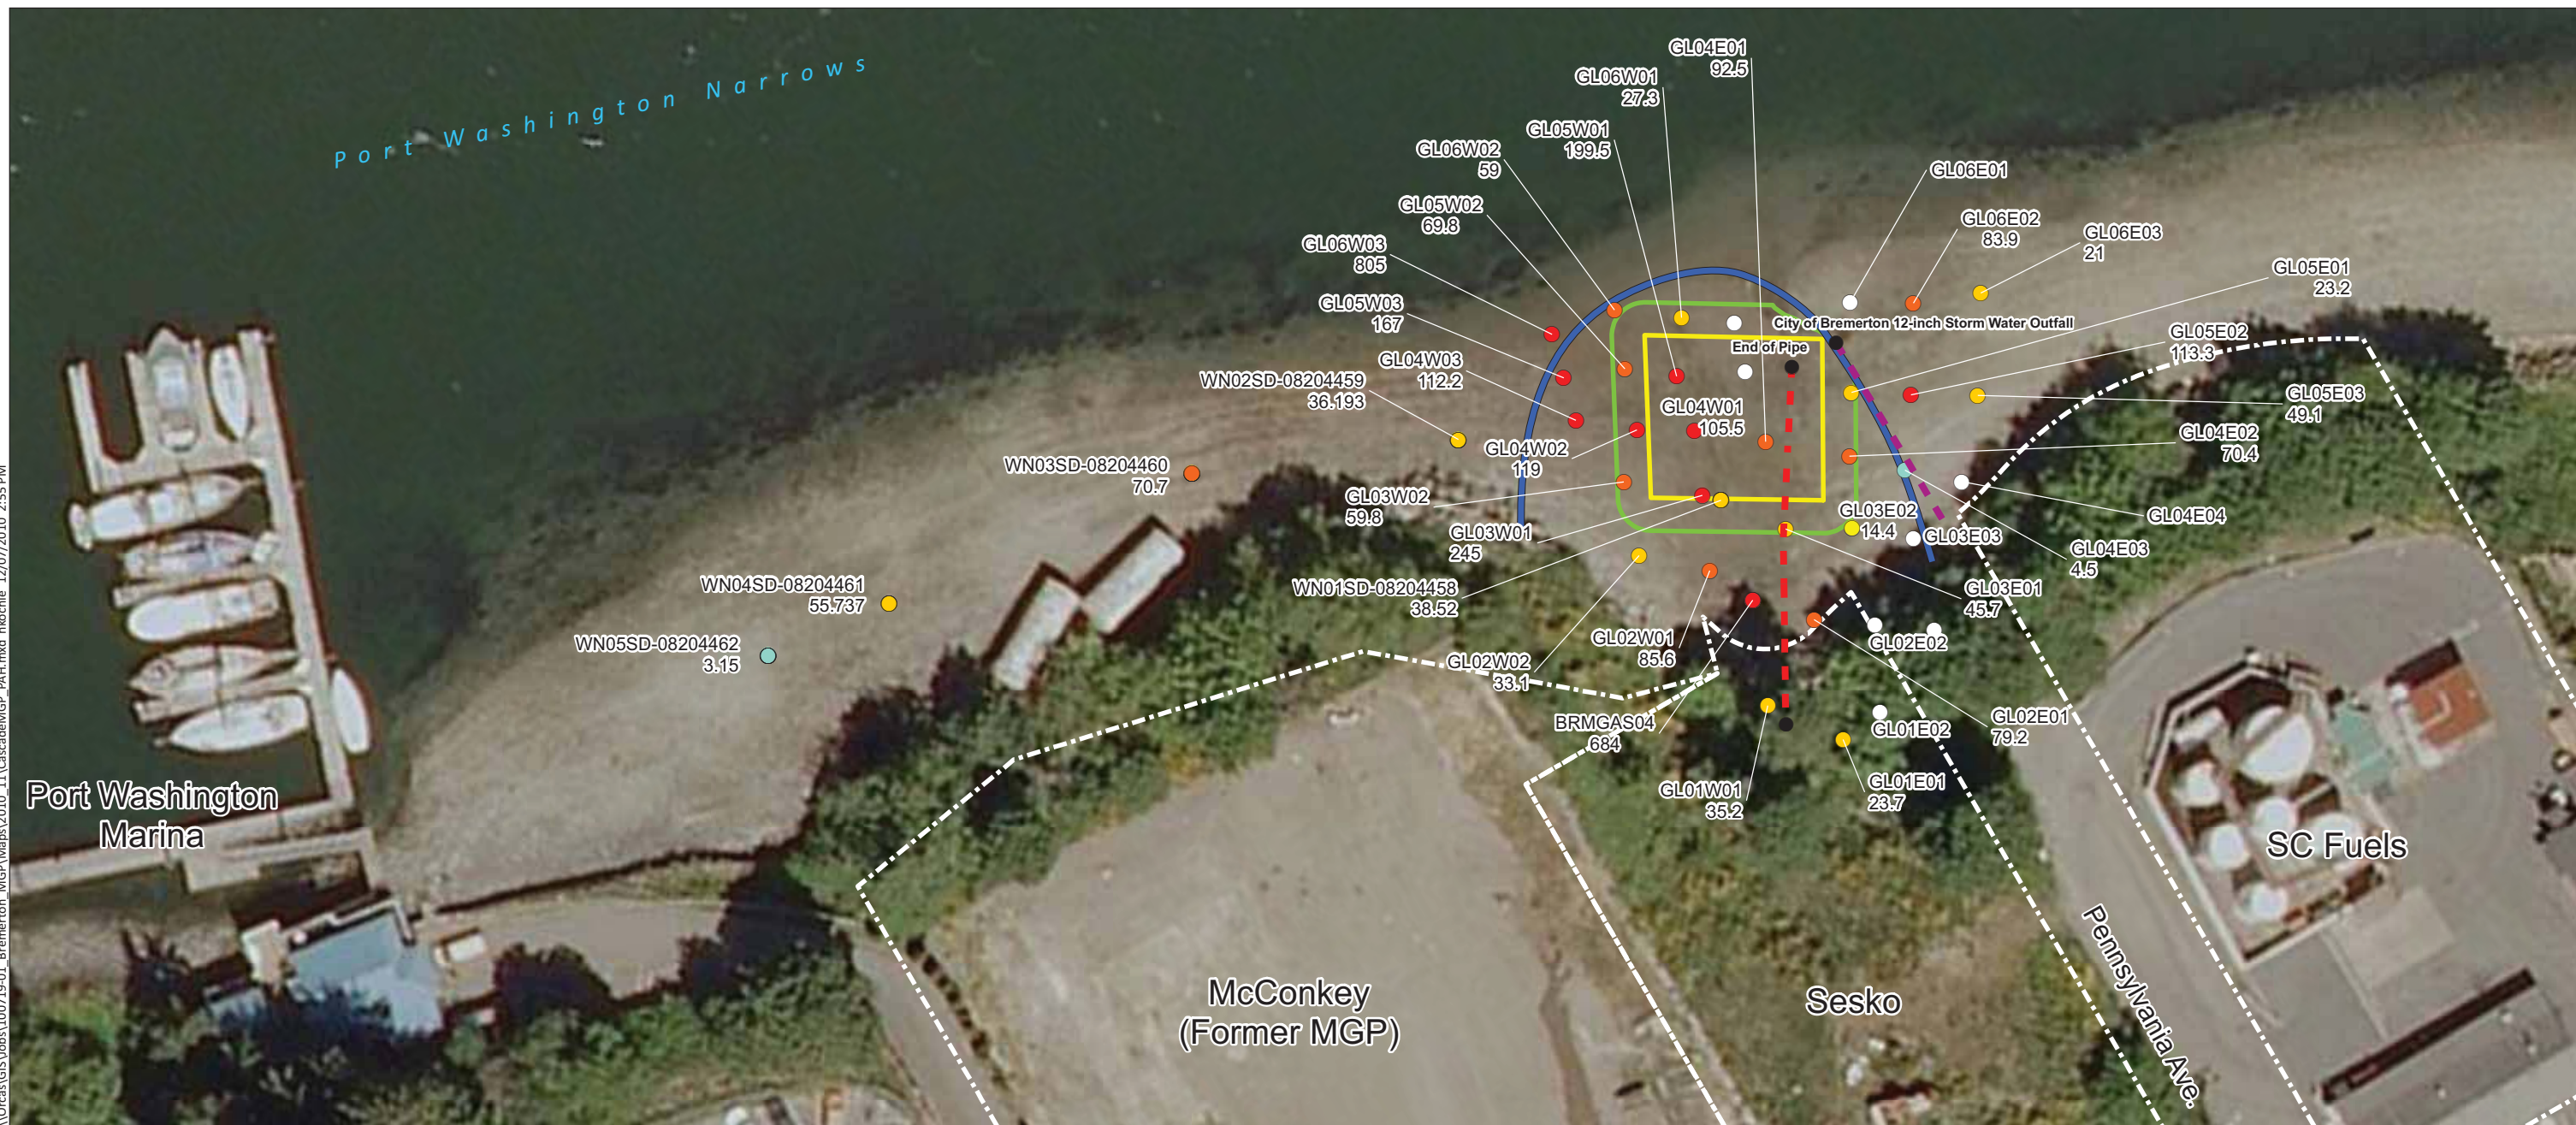
Detected Total PAH Concentrations (mg/kg)

- End of Pipe
- 12-inch Concrete Pipe Configuration
- Assumed City of Bremerton 12-inch Storm Water Pipe Configuration
- Boom Location
- Extent of Organo-Clay Mat
- Cover of Organo-Clay Mat

EPA, in coordination with USCG and in conjunction with the response activities, collected surface sediment samples for analysis of polycyclic aromatic hydrocarbons (PAHs). The sample locations and sample results of this analysis and the results of sediment samples collected in August 2009 (Ecology and Environment) are presented on Figure 2. The Washington State Department of Ecology (Ecology) analyzed a sample of material collected near the Pipe by KCHD on September 24, 2010, only for hydrocarbon identification by HC-ID (Appendix B). The sample was identified by the laboratory as a "coal-tar creosote" type of product.

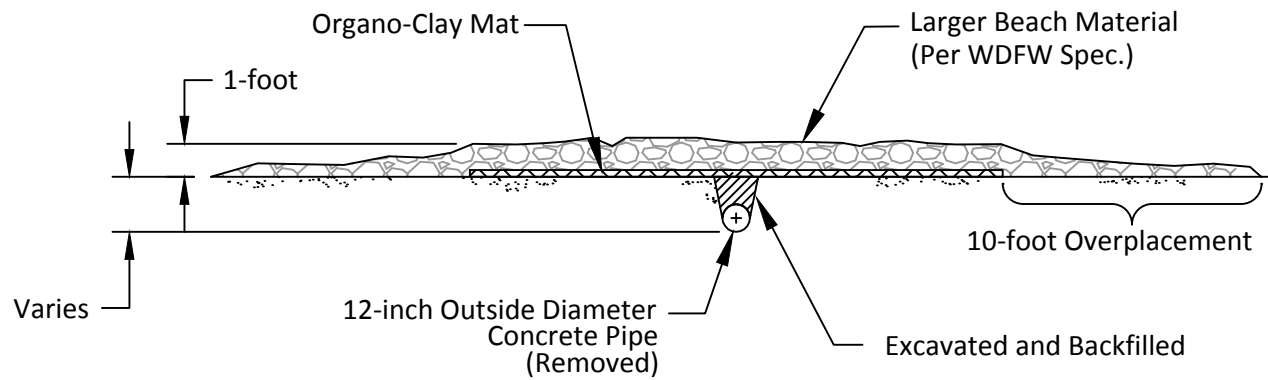
Typical Organo-Clay Mat Placement and Cover

After the panels were in place, the LGP excavator was used to place large beach material on the Organo-Clay mat. The large beach material was first placed on the eastern edge of the mat to create a pathway to the lower intertidal zone for cover placement. Once the large beach material was placed to a nominal 1-foot thickness covering the eastern portion of the mat, the LGP excavator proceeded to the lower intertidal area. Using this method, the entire mat and 10-foot overplacement area was covered before tidal inundation. Care was taken not to cover the City of Bremerton 10-inch stormwater outfall and its upgradient pipe sections, which are located northeast of the mat (Figure 4). A cross-section representing the Organo-Clay mat and cover is presented in Figure 5. The containment boom system was checked and determined to be clean enough to be re-used and extended to contain the entire mat and cover area (Figure 4). Approximately 2,600 square feet of sediment was covered with the Organo-Clay mat and 4,800 square feet of mat and sediment was covered with the large beach material.

Small beach material was transported by crane to the upper intertidal area and placed in the areas where the tracks were visible until the LGP excavator was in place to be removed from the intertidal area by the crane. All construction materials were gathered and placed into a skip box and removed by crane from the intertidal area.
